R22 SERVICE BULLETIN SB-120B
(supersedes R22 Service Bulletin SB-120A)

SUBJECT: Tail Rotor Blade Inspection and Replacement

EFFECTIVITY: P/N A029-2 tail rotor blade S/Ns 11279 and prior (A029-2 REV U and prior). Affected blades were factory-installed on R22 Helicopter S/Ns 4873 and prior.

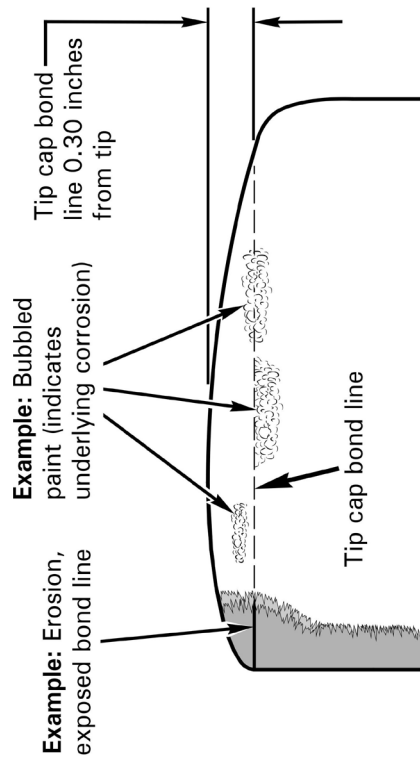
Refer to Figure below.

To be performed before the first flight of each day. May be performed by pilot or mechanic. Conduct visual inspection of tail rotor tip area. If bubbled paint or other evidence of corrosion is observed at or adjacent to tip cap bond line or if any portion of tip cap bond line is exposed, do not fly helicopter. Comply with latest revision of R22 SL-93 prior to further flight.
