**R44 SERVICE BULLETIN SB-112C**  
(supersedes R44 Service Bulletin SB-112B)

**DATE:** 22 December 2022      **REV C:** 28 January 2025

**SUBJECT:** Tail Rotor Blade Inspection and Replacement

**EFFECTIVITY:** P/N C029-3 tail rotor blade S/Ns 14329 and prior (C029-3 REV Q and prior). Affected blades were factory-installed on the following aircraft:

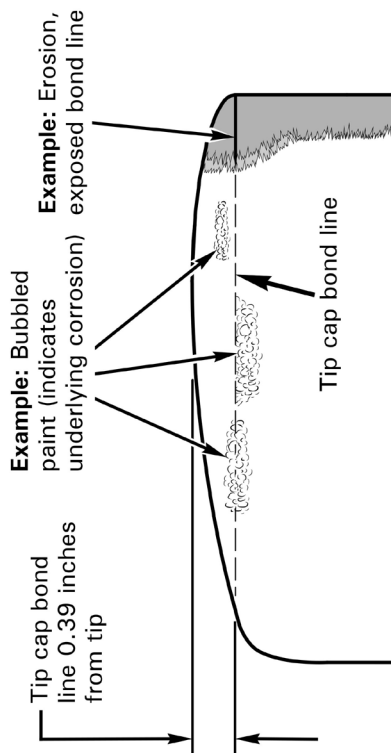
To be performed before the first flight of each day. May be performed by pilot or mechanic. Conduct visual inspection of tail rotor tip area. If bubbled paint or other evidence of corrosion is observed at or adjacent to tip cap bond line or if any portion of tip cap bond line is exposed, do not fly helicopter. Comply with latest revision of R44 SL-82 prior to further flight.
