**R66 SERVICE BULLETIN SB-41C**  
(supersedes R66 Service Bulletin SB-41B)

**DATE:** 22 December 2022      **REV C:** 28 January 2025

**SUBJECT:** Tail Rotor Blade Inspection and Replacement

**EFFECTIVITY:** P/N F029-1 tail rotor blade S/Ns 3099 and prior (F029-1 REV F and prior).

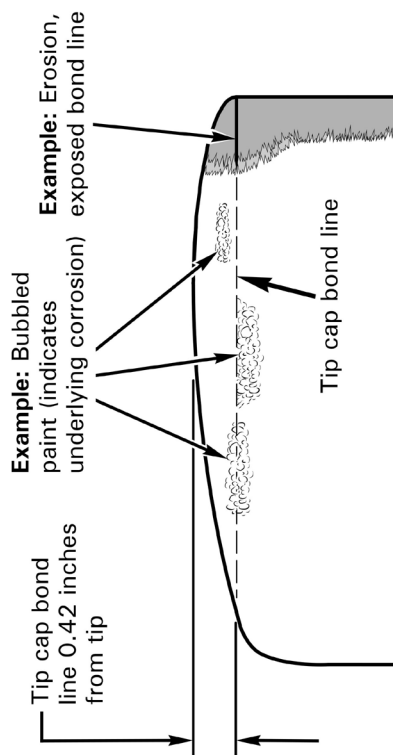
To be performed before the first flight of each day. May be performed by pilot or mechanic. Conduct visual inspection of tail rotor tip area. If bubbled paint or other evidence of corrosion is observed at or adjacent to tip cap bond line or if any portion of tip cap bond line is exposed, do not fly helicopter. Comply with latest revision of R66 SL-40 prior to further flight.
