R22 SERVICE LETTER SL-86

SUBJECT: Inspection After Stabilizer Damage

ROTORCRAFT AFFECTED: All R22-series Helicopters.

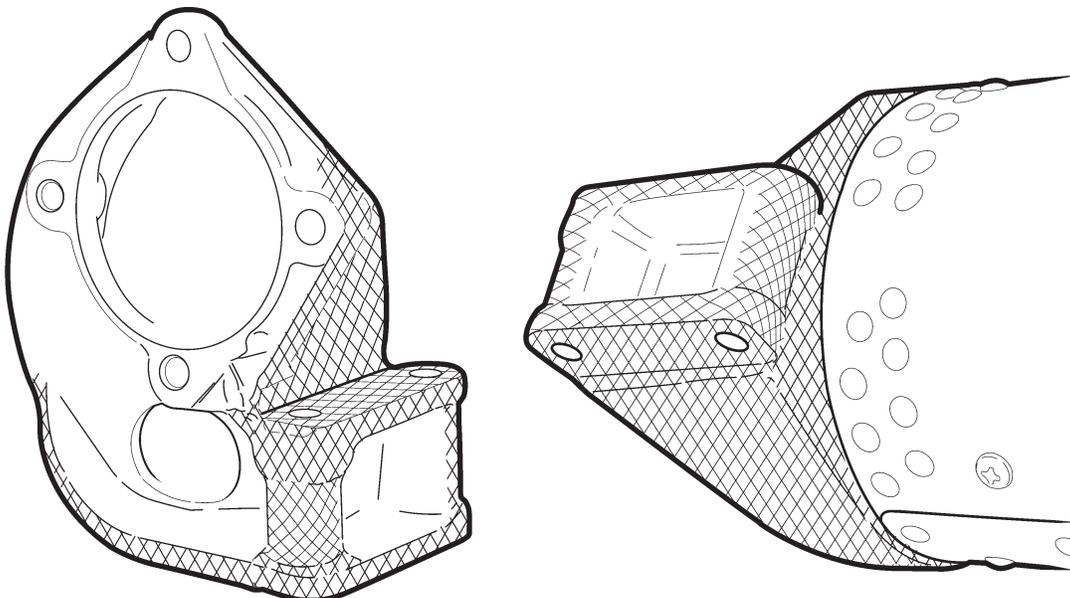
1. On associated tailcone's aft casting, strip paint from cross-hatched surfaces depicted below.
2. Perform fluorescent penetrant inspection (FPI) per ASTM E1417 of stripped surfaces. Replace tailcone if crack is indicated.
3. Prime & paint stripped surfaces per Maintenance Manual.

For damage to an installed A042-1 upper vertical stabilizer, A043-1 lower vertical stabilizer, and/or A044-1 horizontal stabilizer that results in denting, tearing, or cracking of stabilizer metal:
