## **R44 SERVICE LETTER SL-72**

## **R66 SERVICE LETTER SL-33**

**SUBJECT:** Inspection After Stabilizer Damage

ROTORCRAFT AFFECTED: All R44-series & R66 Helicopters.

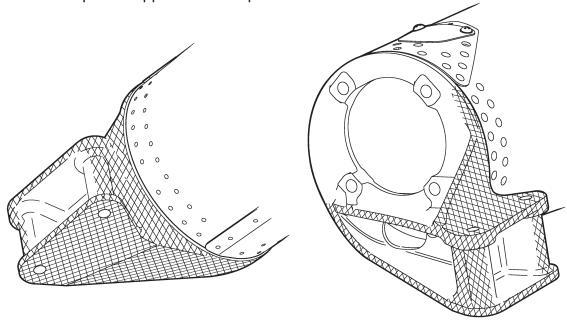
For damage to an installed C042-1 upper vertical stabilizer, C043-1 lower vertical stabilizer, and/or C044-1 horizontal stabilizer that results in denting, tearing, or cracking of stabilizer metal:

- 1. On associated tailcone's aft casting, strip paint from cross-hatched surfaces depicted below.
- 2. Perform fluorescent penetrant inspection (FPI) per ASTM E1417 of stripped surfaces. Replace tailcone if crack is indicated.
