## HOW ROBINSON HELICOPTER ARRIVED AT ITS NEW TAIL DESIGN

BY ELAN HEAD

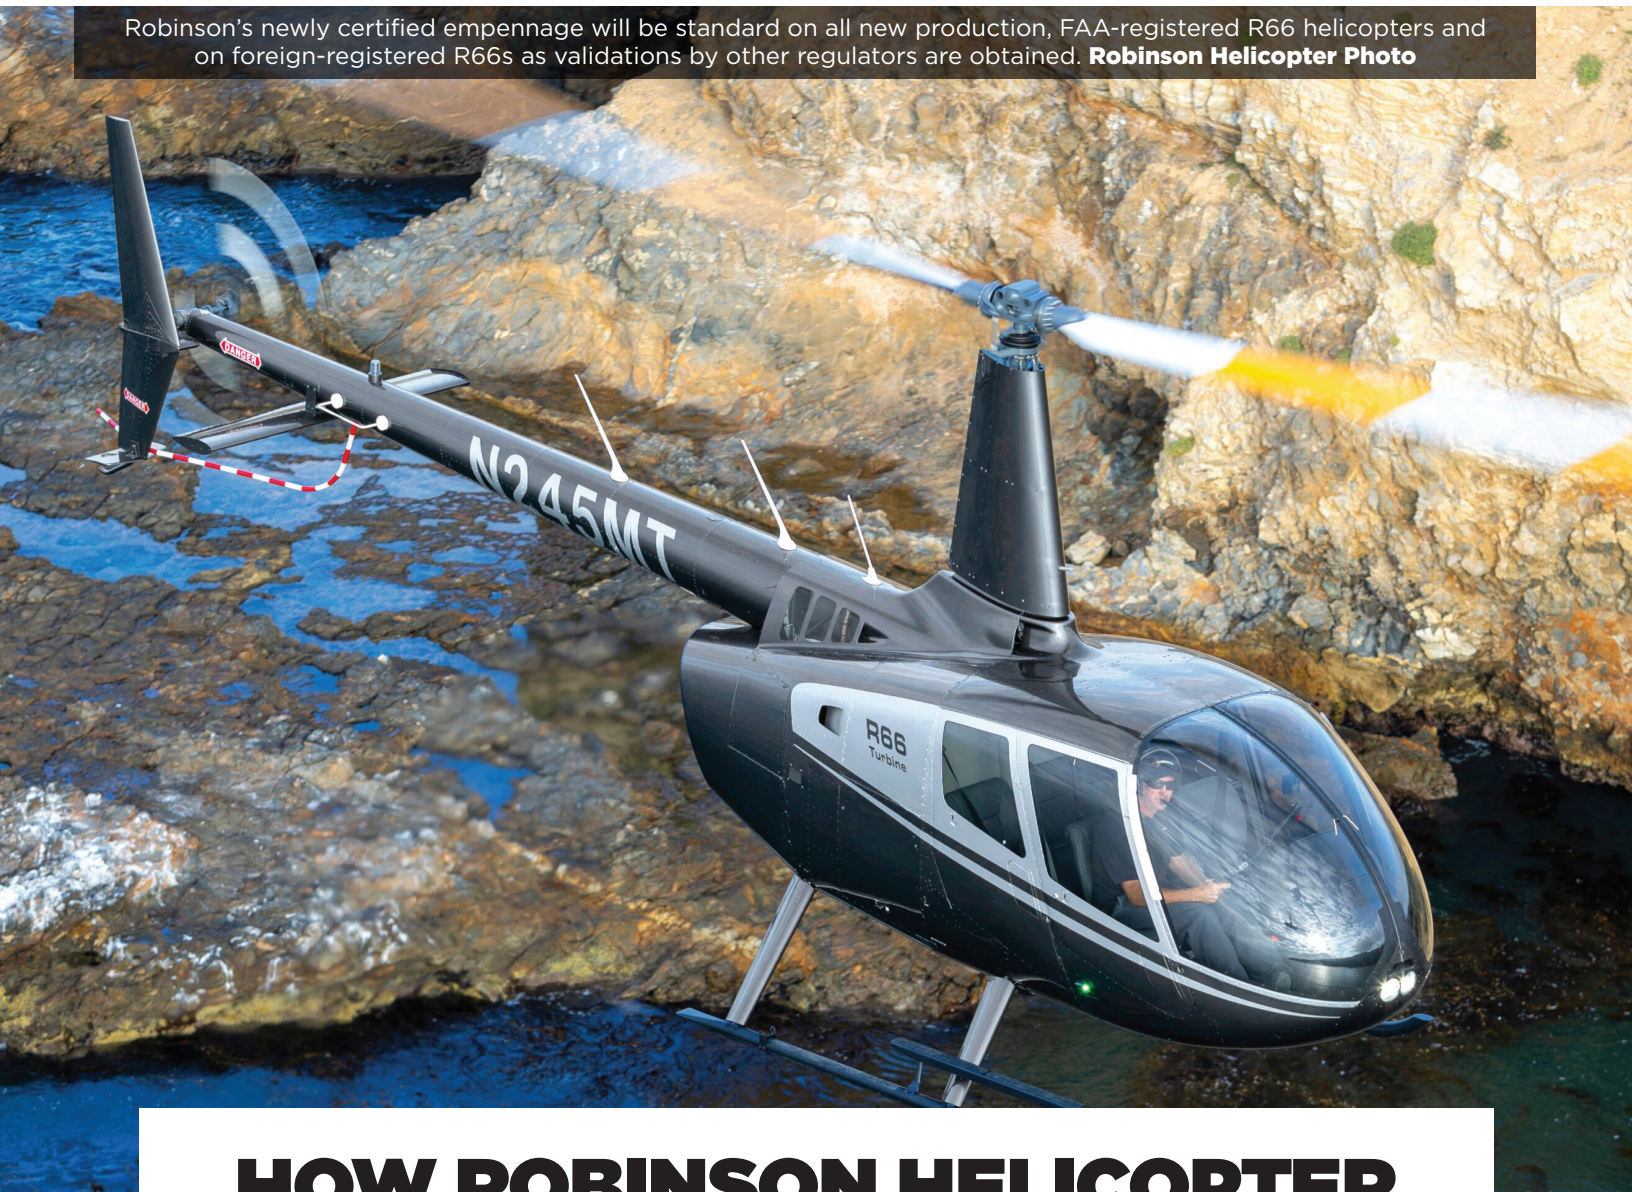
Robinson's newly certified empennage will be standard on all new production, FAA-registered R66 helicopters and on foreign-registered R66s as validations by other regulators are obtained. **Robinson Helicopter Photo**

As previously reported, the new empennage replaces the R66's original horizontal stabilizer — which is mounted on the right side of the tail, directly across from the tail rotor — with a different stabilizer that is forward of the tail rotor and symmetrical across both sides of the tail cone. The new stabilizer is designed to enhance roll stability during high-speed flight, a regime in which the aircraft is at increased risk for mast bumping.

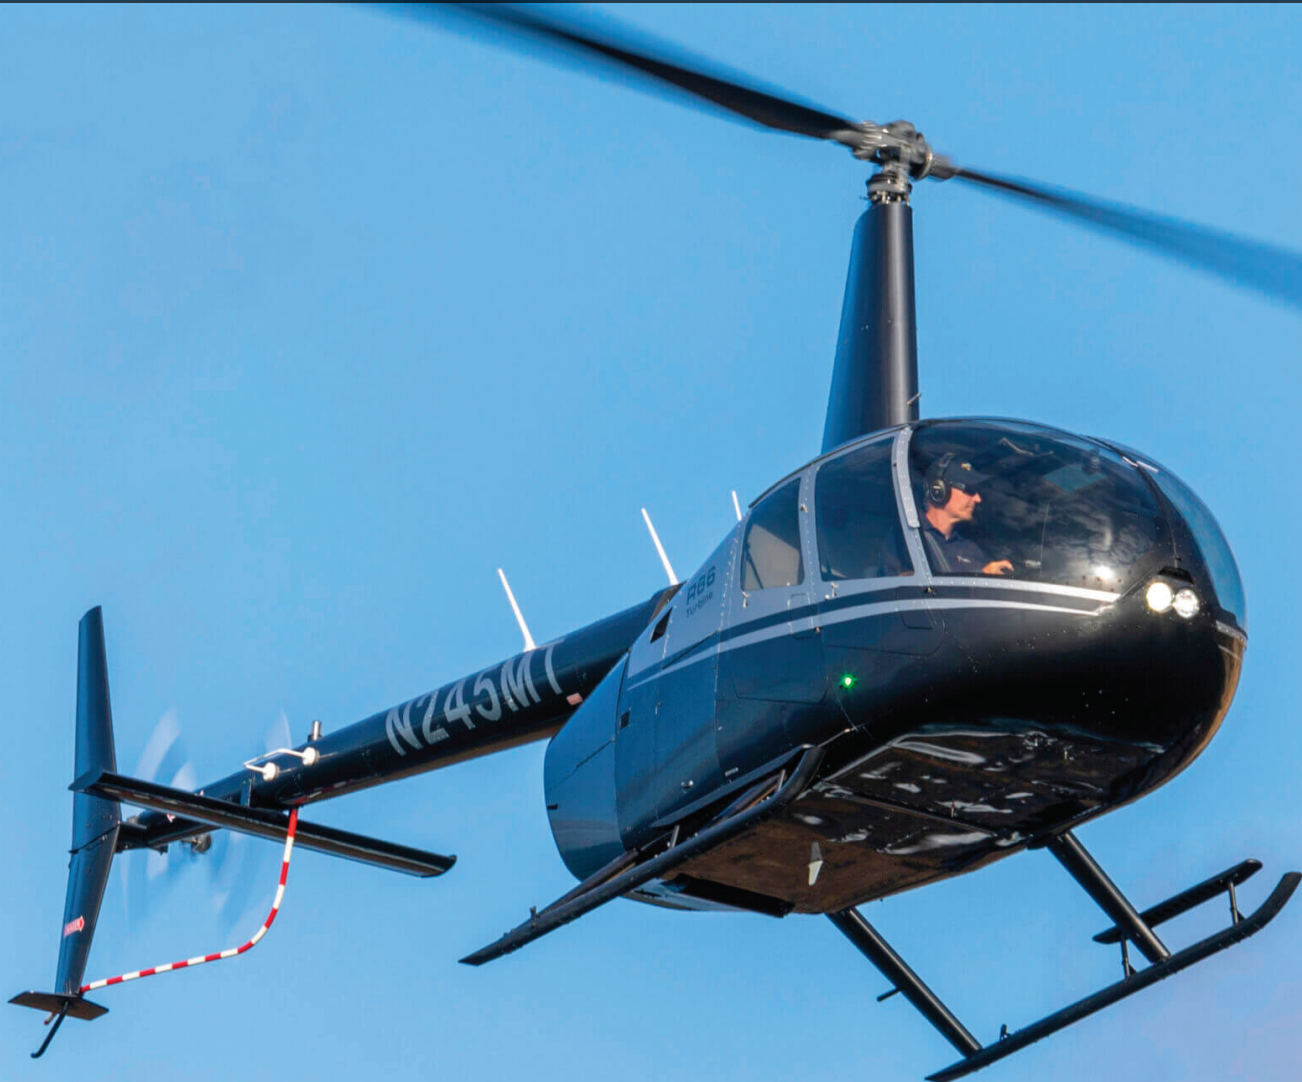
The new empennage includes a symmetrical horizontal stabilizer and a new tail cone, both with extended TBOs of 4,000 hours. In the future, operators will have the option of retrofitting older aircraft with the full empennage or just the stabilizer.

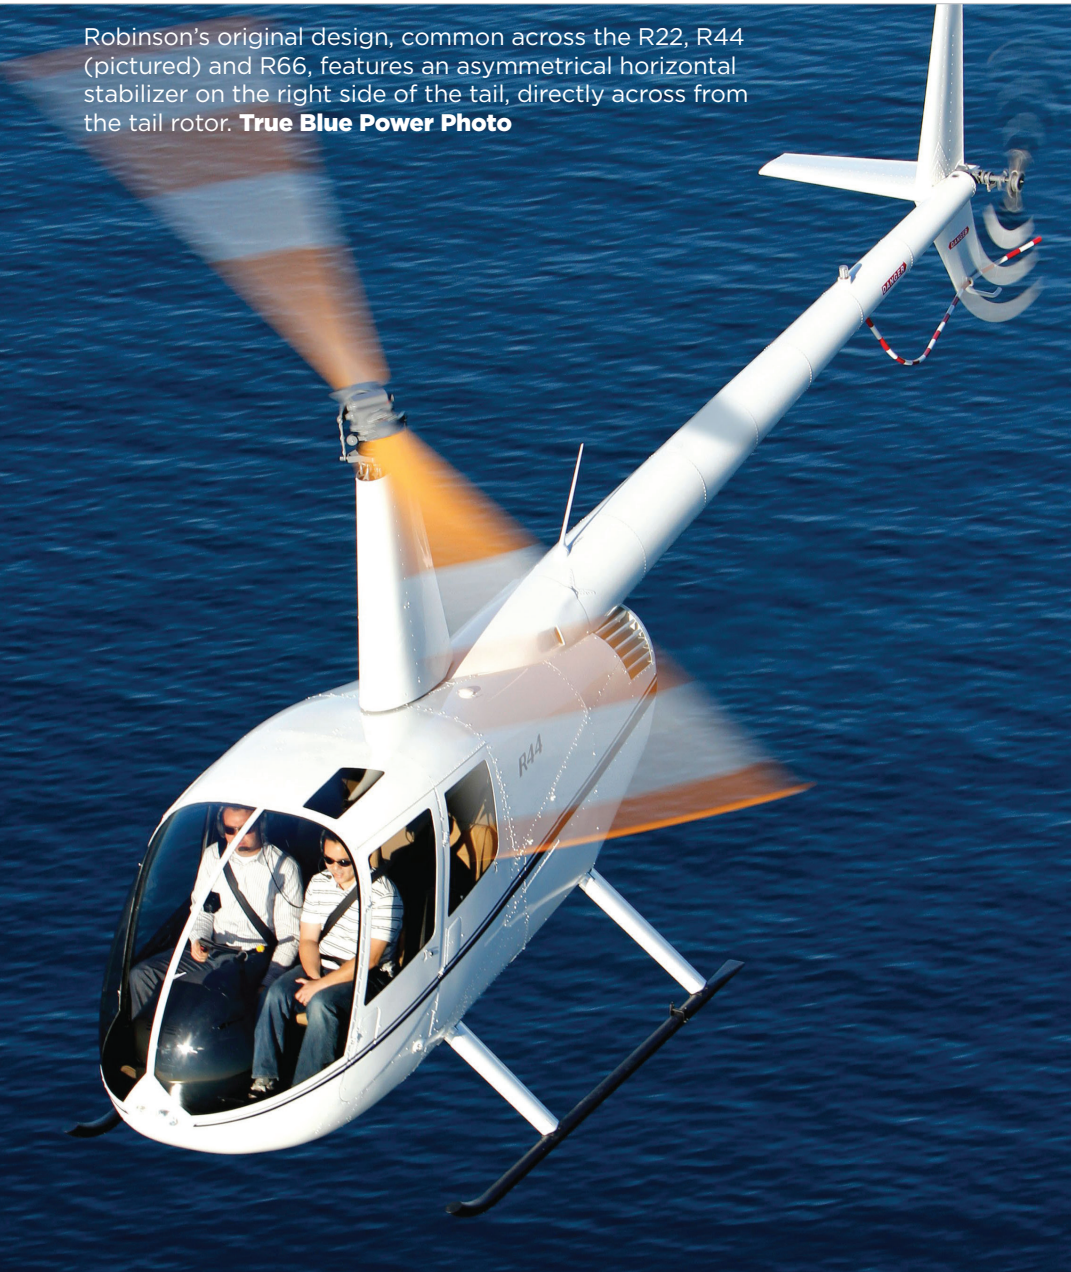
Robinson's original design, common across the R22, R44 (pictured) and R66, features an asymmetrical horizontal stabilizer on the right side of the tail, directly across from the tail rotor. **True Blue Power Photo**

The simulation showed that tail rotor thrust was not the primary contributor to the rolling behavior of the R66 in low-G conditions — in contrast to the conclusions reached by the U.S. Army for its Hueys and Cobras, which have tail rotors that are mounted much higher. Instead, the simulation identified the asymmetric horizontal stabilizer on the right side of the tail, which exerts a downforce in forward flight, as the most significant contributor to the R66’s right rolling moment when the main rotor was suddenly unloaded.

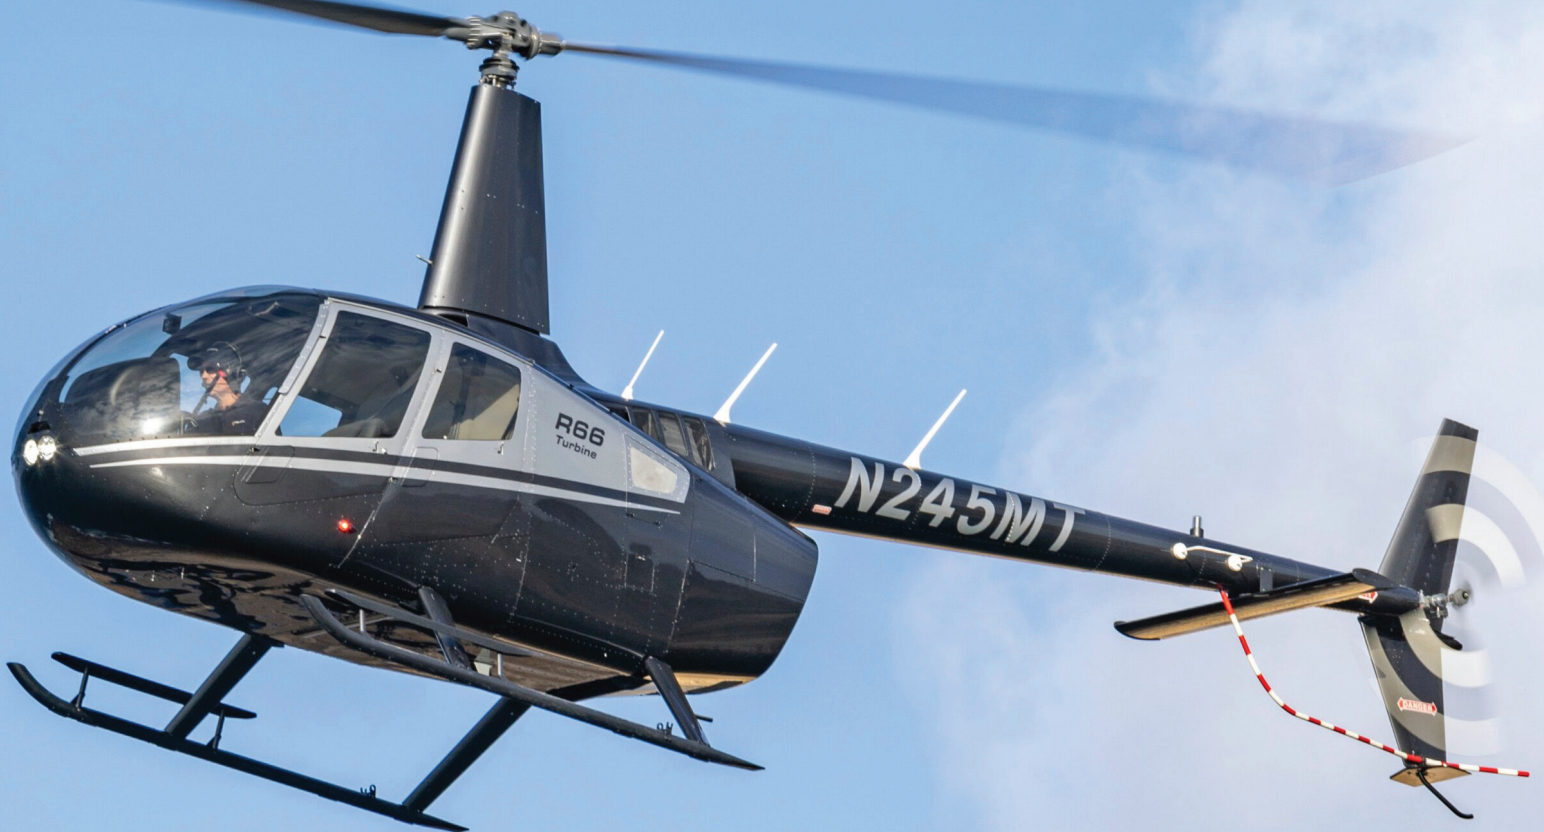
The R66 (pictured) is the first model to achieve certification with the new empennage by the FAA, but certification programs for the R44 and R22 are also under way, as is validation by the European Union Aviation Safety Agency and other regulators.

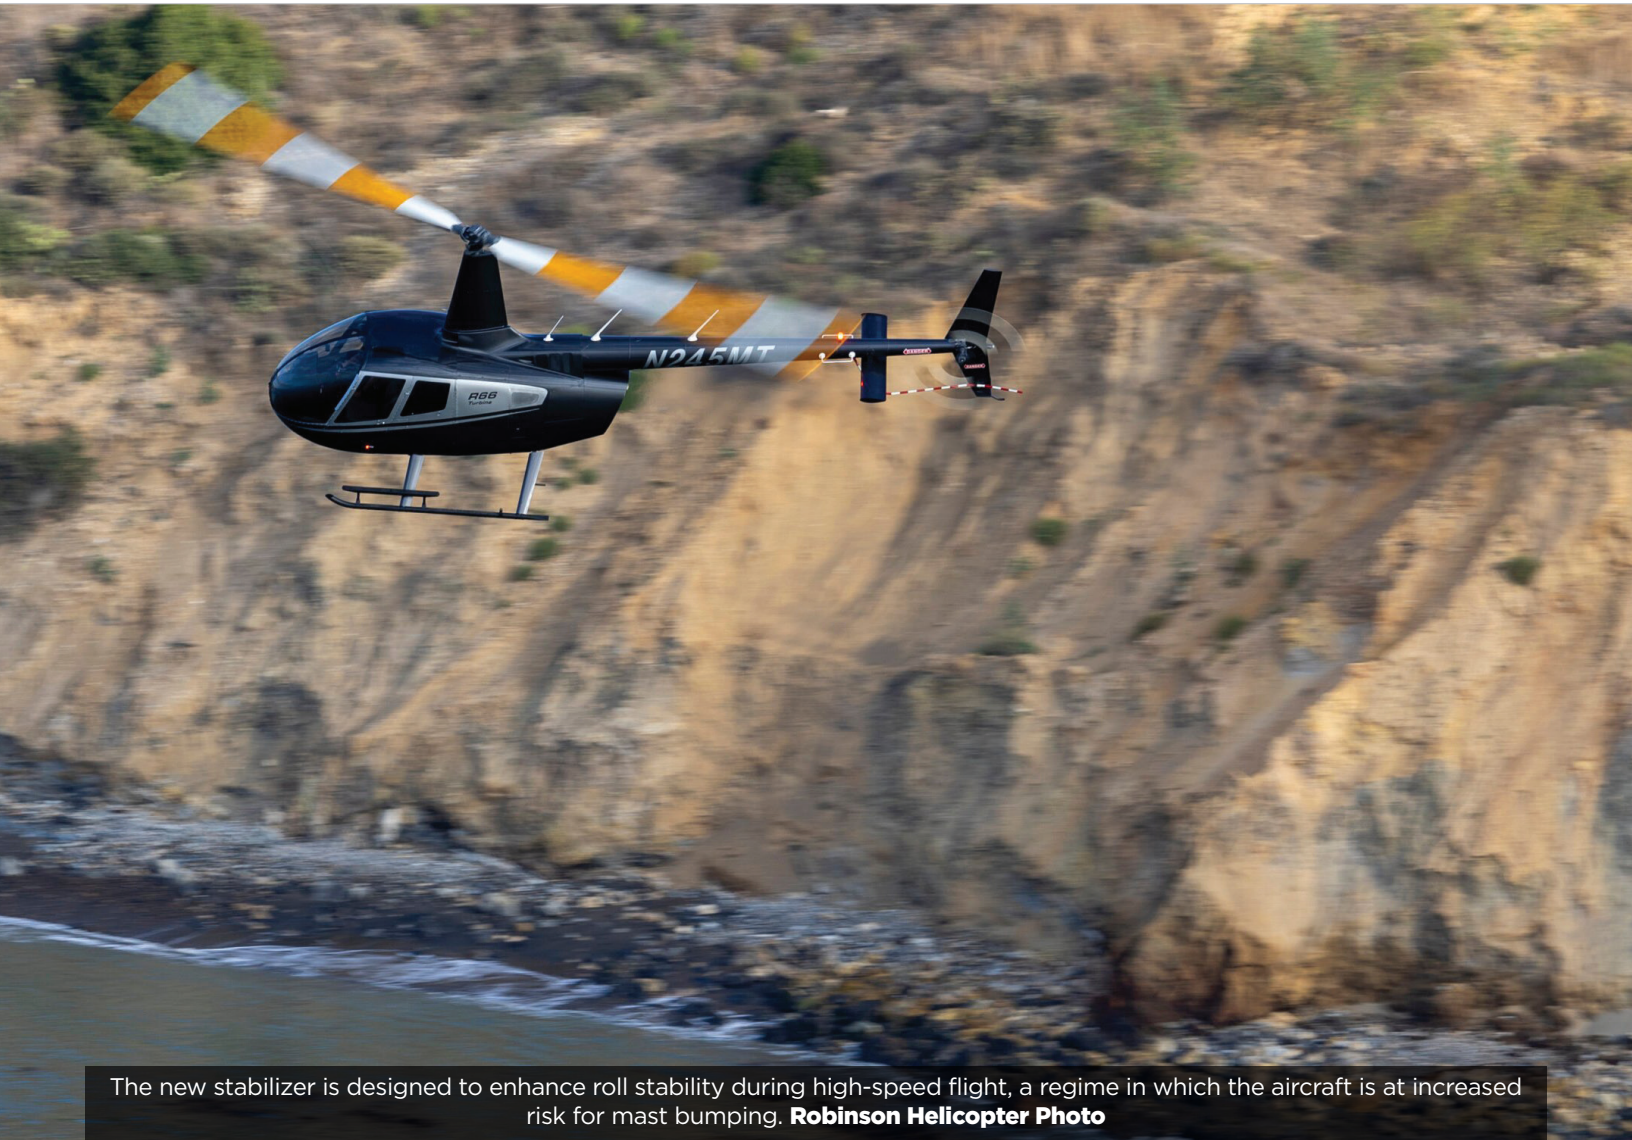
The new stabilizer is designed to enhance roll stability during high-speed flight, a regime in which the aircraft is at increased risk for mast bumping. **Robinson Helicopter Photo**

“The way we teased it out was over a bunch of different simulation setups,” Smith explained. When the model showed that adding a balancing aerodynamic surface on the left side of the tail would substantially decrease the rolling moment, Robinson’s engineers were inspired to build a prototype. Flight testing by the company’s experienced test pilots confirmed that the new, balanced stabilizer greatly reduced the tendency of the aircraft to roll to the right under conditions of low G.
