CHAPTER 2

INSPECTION

2.000 Introduction

The R44 helicopter must be inspected periodically to verify it is in airworthy condition. Required inspection intervals are maximum 100 hours time in service or 12 calendar months (annually), whichever occurs first; the inspection interval may be extended up to 10 hours, without accumulation, if allowed by local regulations. Fluid leaks, discoloration, | dents, scratches, nicks, cracks, galling, chafing, fretting, and corrosion all warrant further investigation. Unairworthy items must be replaced or repaired as allowed by Robinson Helicopter Company. This section contains procedures for performing the required periodic airframe inspections.

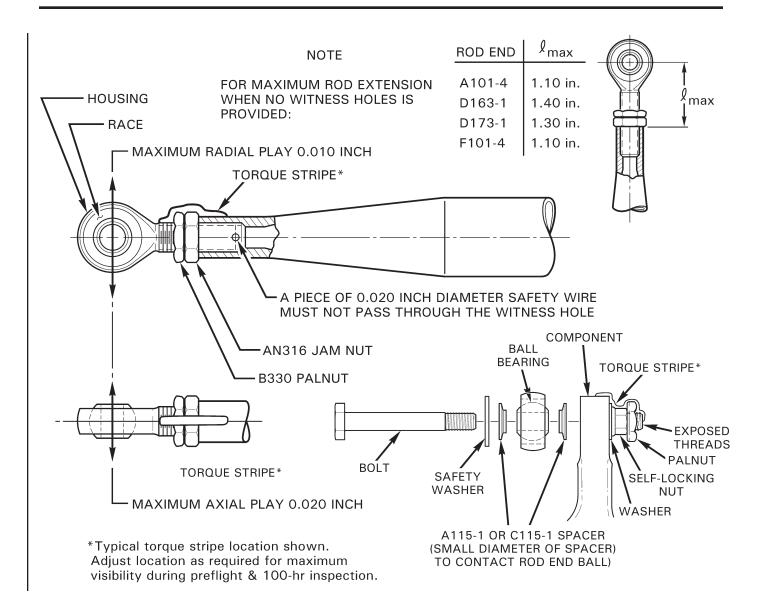
FIGURE 2-1 ROD END AND SPHERICAL BEARING PLAY LIMITS AND TORQUE STRIPE APPLICATION

- 1. Maximum axial play: 0.020 inch (for A104-4 bearing only: 0.035 inch axial play) | Maximum radial play: 0.010 inch
- 2. Looseness between bearing outer race and rod end housing is not permitted.
- Rod ends not riveted in place must block passage of 0.020-inch diameter wire through witness hole. Refer to Figure 2-1 for maximum rod end extension when no witness hole is provided.
- 4. Rod end jam nuts and palnuts must be torqued per § 23-32 and torque striped per Figure 2-1 at the most visible position for pre-flight inspection. Torque stripe must extend across nuts to both rod end shank and push-pull tube (or pitch link barrel, yoke, support, strut, etc.). Torque stripes are subject to deterioration and must be periodically renewed.
- 5. Refer to Figure 2-1A. Rod ends must be positioned (centered) to allow as much push-pull tube or link rotational movement as possible without binding.

If, during inspection, the remaining torque stripe on a fastener is insufficient to determine joint integrity, then remove accompanying palnut as required and apply specified torque to fastener. If fastener moves, disassemble joint and inspect parts for damage such as fretting, thread deformation, hole elongation, etc.; replace damaged parts. If fastener does not move, install new palnut as required & standard torque per § 1.320. Torque stripe fastener per Figure 2-1.

Elastic Trim Cords – Cyclic : With cyclic forward-right, feel forward elastic trim cords for voids which may indicate broken strands.	
	Heater Hose: Check heater hose for collapsed areas and chafing.	
	Fasteners and Torque Stripes: Inspect condition and verify security of all fasteners. Renew deteriorated torque stripes per Figure 2-1.

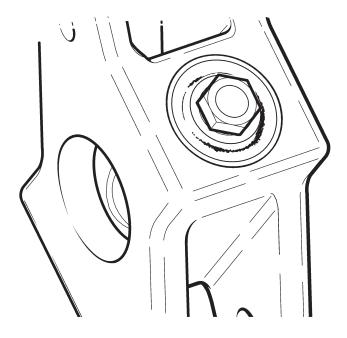
FIGURE 2-2A ELASTOMER FATIGUE

Small surface cracks (fatigue cracks) and elastomer dust or "eraser crumbs" (see Figure 2-2A) are normal and are not cause for replacement. As cracks grow, enough elastomer will be lost to cause reduced stiffness and increased vibration. If deep (greater than 0.10 inch) cracks are present over more than 25% of elastomer face, replace bearing.

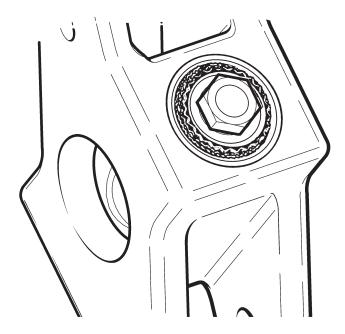
FIGURE 2-2B ELASTOMER OIL CONTAMINATION

Avoid exposure to oil, grease, hydraulic fluid, cleaning solvent, and rust-preventative fluids. Immediately wash off any such contaminants with detergent and water. Contaminated bearings exhibit swelling, wavy edges, or debonding (see Figure 2-2B) and must be replaced.

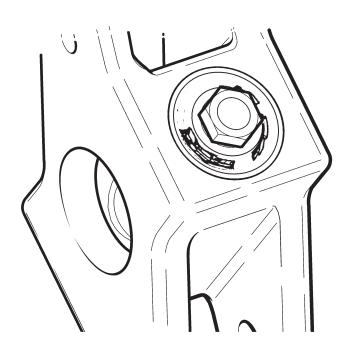
FIGURE 2-2C ELASTOMER OVERLOAD

Overload occurs when elastomer's tensile strength or rubber-to-metal bond strength is exceeded. This can occur when normal loads are applied to a bearing weakened by fatigue or oil contamination. Overload is indicated by large extrusions from and large clean cracks in elastomer as shown in Figure 2-2C.

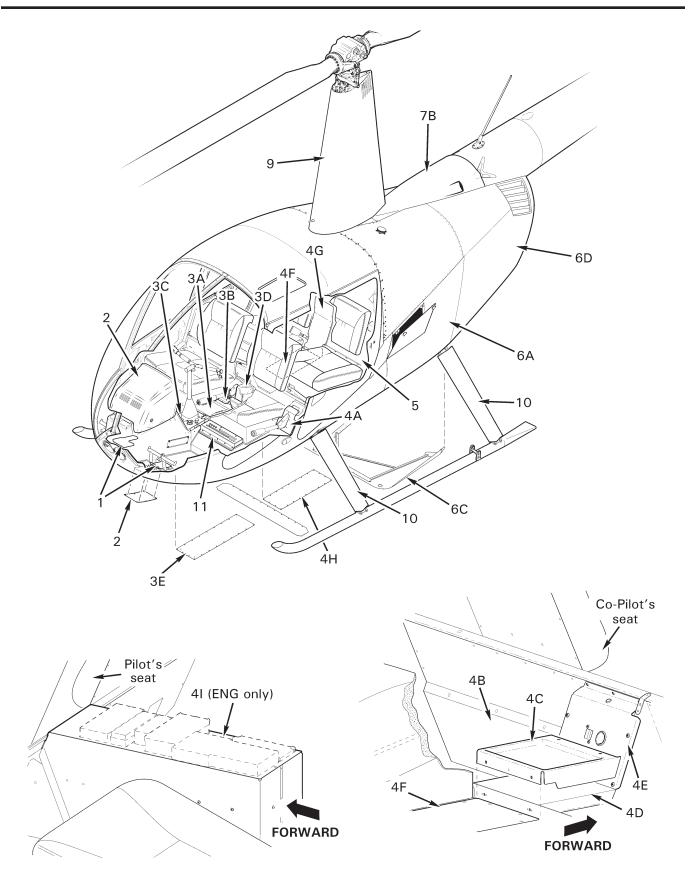
FIGURE 2-4 ACCESS AND INSPECTION PANELS

Numbers in parentheses indicate access location per Figures 2-4 and 2-4A.

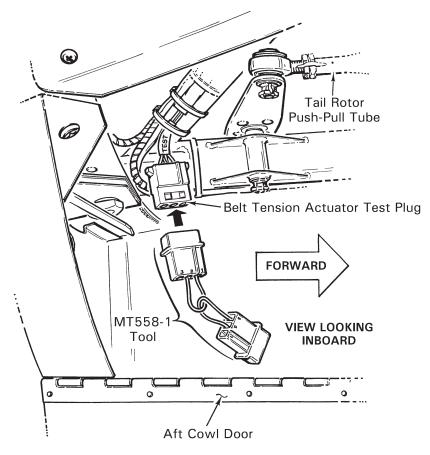
FIGURE 2-6 MT558-1 TOOL INSTALLATION

Check actuator for failed-closed spring switch as follows (actuator electrical harness must be equipped with "Test" plug per Figure 2-6):

If gearmotor activates when installing MT558-1 tool then a spring switch has failed in closed position; immediately remove MT558-1 to prevent actuator damage.

- b. Disconnect MT558-1 tool, connect opposite end to actuator test plug, and verify gearmotor remains off.
- c. Disengage clutch and turn BATTERY switch off.
- d. MT558-1 pins 1 & 2 jumper tests wire 98 spring switch; pins 2 & 3 jumper tests wire 91 spring switch (see Figure 14-1D). Replace any malfunctioning switch per § 7.551 before further flight.

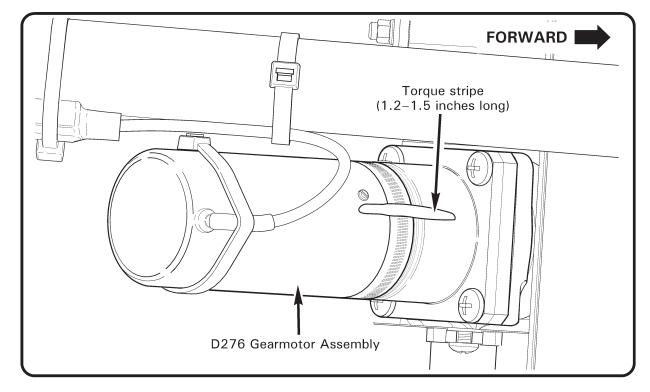
FIGURE 2-6A GEARMOTOR ASSEMBLY TORQUE STRIPE

Gearmotor Assembly Torque Stripe: Refer to Figure 2-6A. Verify torque stripe is not broken or missing. Renew deteriorated torque stripe as required. _

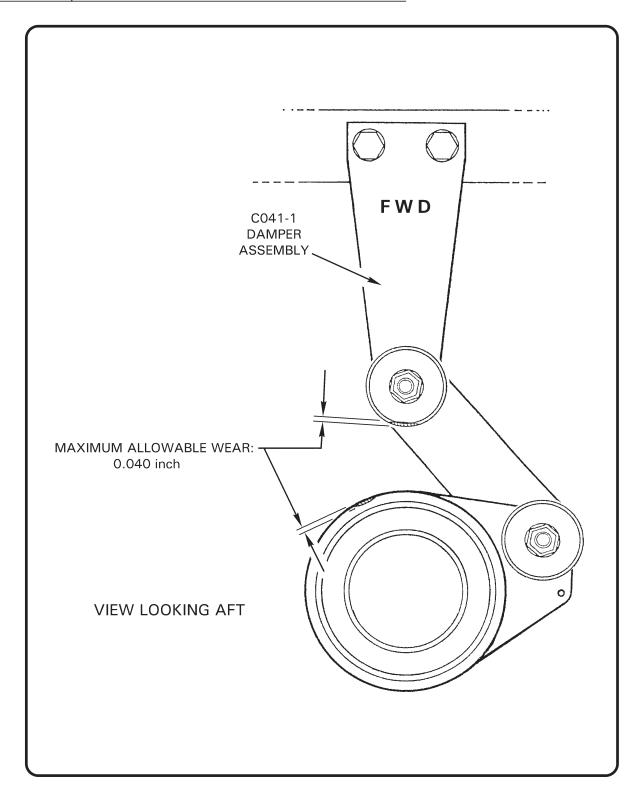
FIGURE 2-8 TAIL ROTOR DRIVE SHAFT DAMPER BEARING INSPECTION

Tail Rotor Drive Shaft Damper Assembly: Inspect condition. Inspect bearing and housing for cracks, corrosion, wear (see Figure 2-8), and bearing seal deterioration. Inspect arms and bearings for cleanliness, cracks, bends and corrosion. Inspect bearing's inner race-to-drive shaft torque stripe.

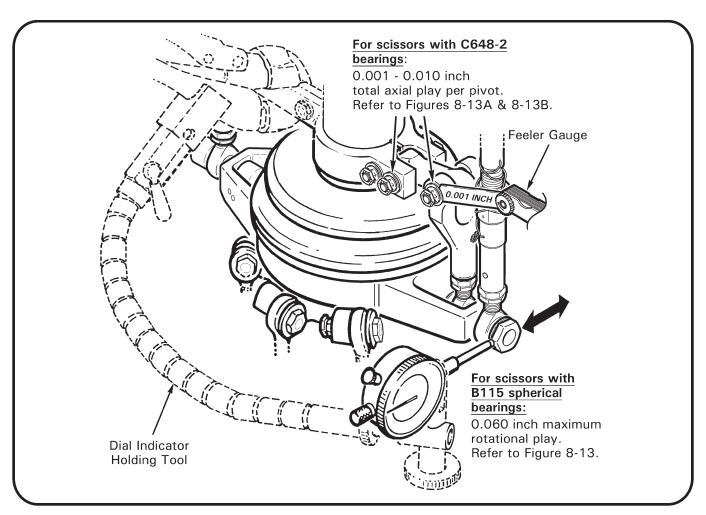
FIGURE 2-9 MEASURING UPPER SWASHPLATE ROTATIONAL PLAY (Identify scissors bearing type and measure as shown)

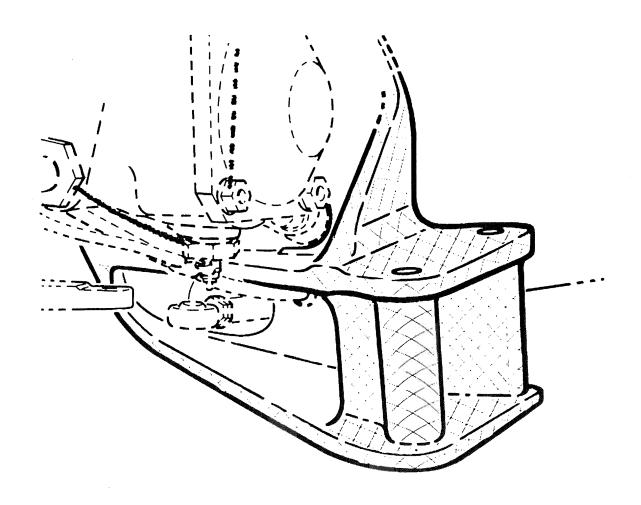
FIGURE 2-14 TAILCONE CASTING TOP AFT VIEW

4.	Remove the stabilizer assembly and dye penetrant inspect the tailcone casting.
		a) Remove paint from tailcone casting in areas shown in Figures 2-14 and 2-14A using a suitable paint remover per Section 1.410.

DYE PENETRANT INSPECT DESIGNATED AREAS AFTER PAINT REMOVAL

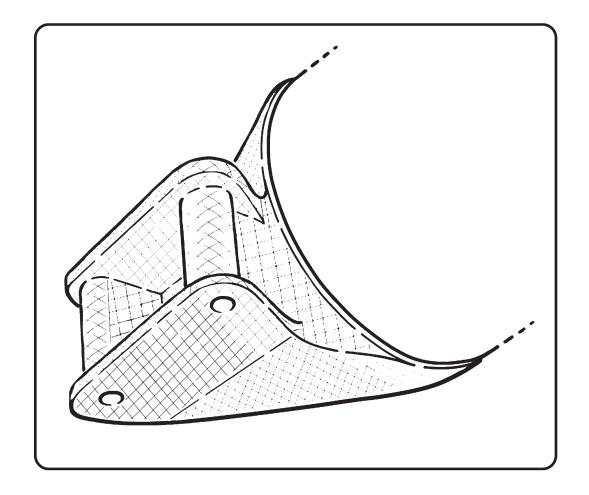
FIGURE 2-14A TAILCONE CASTING BOTTOM FWD VIEW

DYE PENETRANT INSPECT DESIGNATED AREAS AFTER PAINT REMOVAL

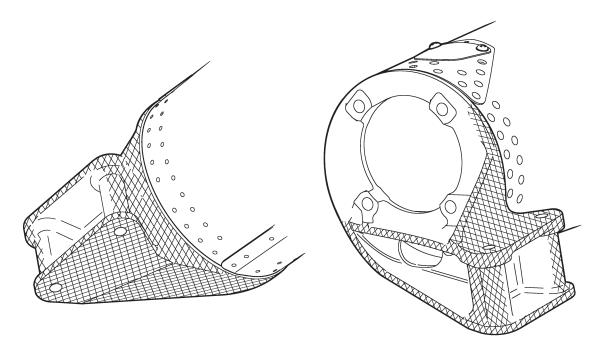
FIGURE 2-18 CROSS-HATCHED SURFACES OF TAILCONE'S AFT CASTING

- 1. On associated tailcone's aft casting, strip paint from cross-hatched surfaces shown in Figure 2-18.
- 2. Fluorescent penetrant inspect (ref. § 23-42) stripped surfaces. Replace tailcone if crack is indicated.
- 3. Prime & paint stripped surfaces per § 23-60.

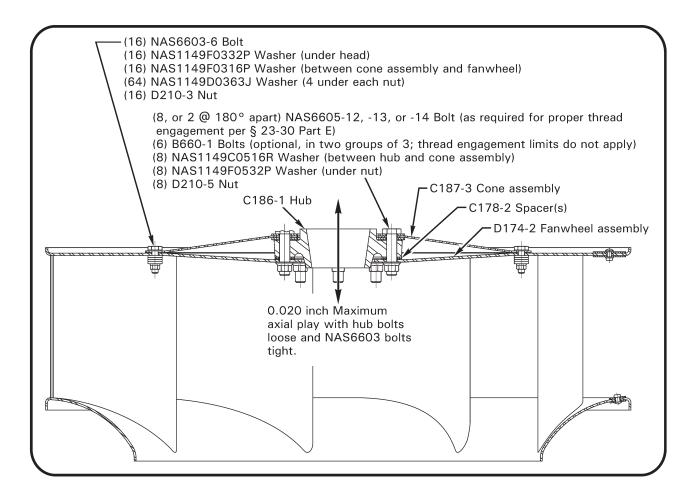
FIGURE 2-19 D174-2 FANWHEEL ASSEMBLY

- 1. If installed, remove D174-2 fanwheel assembly per § 6.210.
- 2. Mark fanwheel assembly parts, including balancing hardware, for identical reassembly.
- 3. Refer to Figure 2-19. Loosen bolts securing C187-3 cone assembly and C186-1 hub to fanwheel. Verify hub axial play does not exceed 0.020 inch with hub bolts loose and NAS6603 bolts tight.
- 4. Remove hardware securing cone assembly, hub, and C178-2 spacer(s) to fanwheel and remove parts, noting relative locations for identical reassembly.
- 5. Visually inspect all components for obvious damage. Verify no elongation of fastener holes. Replace parts as required.
- 6. Assemble fanwheel wet with approved primer (chromate primer preferred; refer to § 23-75) between all clamping surfaces; while primer is wet, special torque D210 nuts per § 23-33. Apply B270-21 protectant to threads and tip of B660-1 bolts, if installed.
