**R44 SERVICE LETTER SL-72**

**R66 SERVICE LETTER SL-33**

**SUBJECT:** Inspection After Stabilizer Damage

**ROTORCRAFT AFFECTED:** All R44-series & R66 Helicopters.

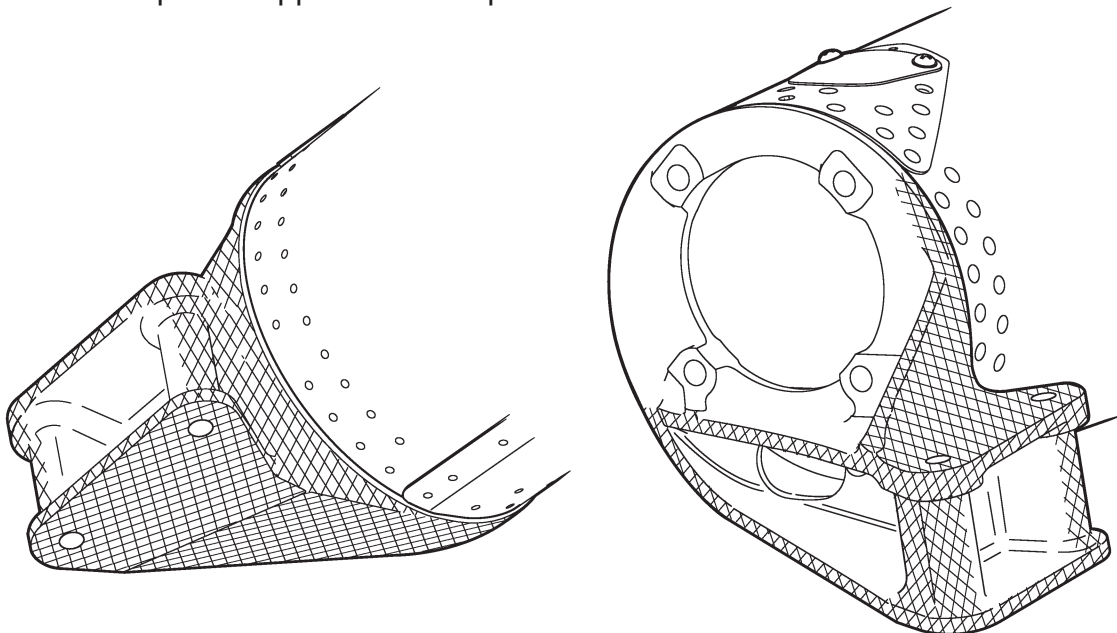
For damage to an installed C042-1 upper vertical stabilizer, C043-1 lower vertical stabilizer, and/or C044-1 horizontal stabilizer that results in denting, tearing, or cracking of stabilizer metal:

1. On associated tailcone's aft casting, strip paint from cross-hatched surfaces depicted below.
2. Perform fluorescent penetrant inspection (FPI) per ASTM E1417 of stripped surfaces. Replace tailcone if crack is indicated.
3. Prime & paint stripped surfaces per Maintenance Manual.
