CHAPTER 2

INSPECTION

2.000 Introduction

The R44 helicopter must be inspected periodically to verify it is in airworthy condition. Required inspection intervals are maximum 100 hours time in service or 12 calendar months (annually), whichever occurs first; the inspection interval may be extended up to 10 hours, without accumulation, if allowed by local regulations. Fluid leaks, discoloration, dents, scratches, nicks, cracks, galling, chafing, fretting, and corrosion all warrant further investigation. Unairworthy items must be replaced or repaired as allowed by Robinson Helicopter Company. This section contains procedures for performing the required periodic airframe inspections.

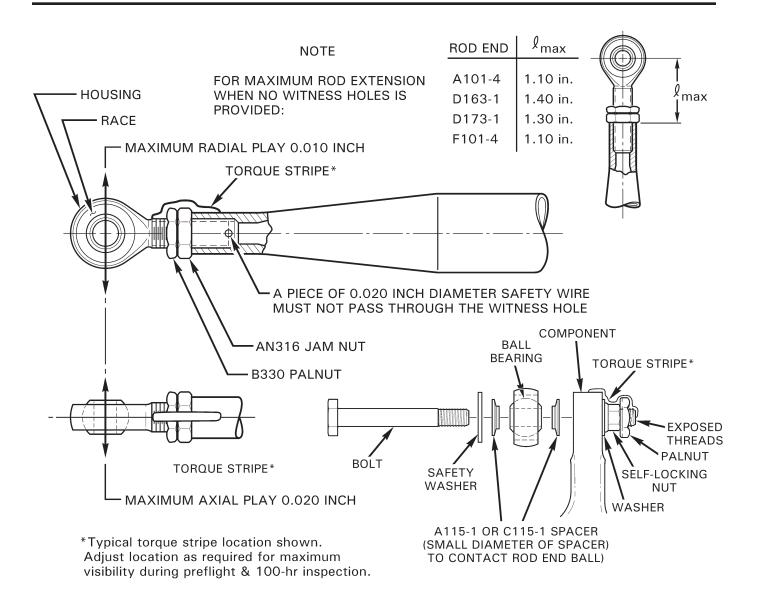
FIGURE 2-1 ROD END AND SPHERICAL BEARING PLAY LIMITS AND TORQUE STRIPE APPLICATION

- Maximum axial play: 0.020 inch (for A104-4 bearing only: 0.035 inch axial play)
 Maximum radial play: 0.010 inch
- 2. Looseness between spherical bearing outer race & rod end housing, or between spherical bearing outer race & part, is not permitted.

- 4. Rod end jam nuts and palnuts must be torqued per § 23-32 and torque striped per Figure 2-1 at the most visible position for pre-flight inspection. Torque stripe must extend across nuts to both rod end shank and push-pull tube (or pitch link barrel, yoke, support, strut, etc.). Torque stripes are subject to deterioration and must be periodically renewed.

If, during inspection, the remaining torque stripe on a fastener is insufficient to determine joint integrity, then remove accompanying palnut as required and apply specified torque to fastener. If fastener moves, disassemble joint and inspect parts for damage such as fretting, thread deformation, hole elongation, etc.; replace damaged parts. If fastener does not move, install new palnut as required & standard torque per § 1.320. Torque stripe fastener per Figure 2-1.

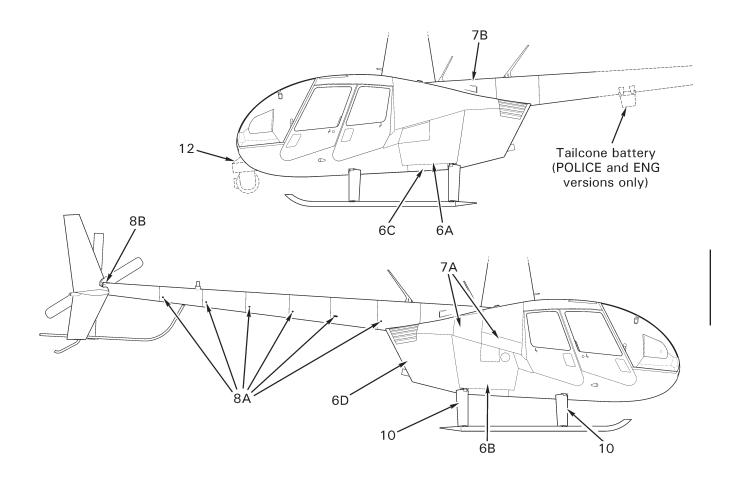
FIGURE 2-4 ACCESS AND INSPECTION PANELS

Numbers in parentheses indicate access location per Figures 2-4 and 2-4A.

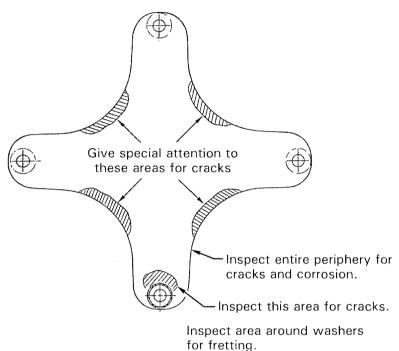
FIGURE 2-5 FLEX PLATE INSPECTION

Forward Flex Plate: Inspect condition, particularly edges. Verify security. Verify bonded washers are securely bonded to both sides of each flex plate arm. Verify operating clearance.

Intermediate Flex Plate and Forward End of Tail Rotor Drive Shaft (see Figure 2-5): Inspect flex plate for cracks and fretting. Inspect yoke-to-drive shaft weld for cracks (steel shafts).	
	Tailcone Attachment: Thoroughly inspect all welds in this area for cracks, corrosion, and security of attaching fasteners. Inspect tailcone mounting area for cracks.

Aft Flex Plate (refer to Figure 2-5): Inspect condition. Verify no obvious damage. If fretting is detected, replace flex plate. Verify bonded washers are installed on both sides of each flex plate arm. Verify security and operating clearance.

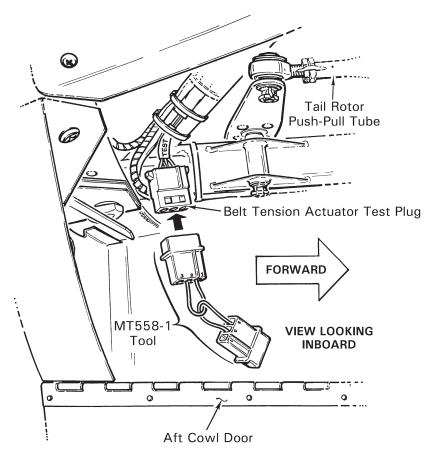
FIGURE 2-6 MT558-1 TOOL INSTALLATION

Check actuator for failed-closed spring switch as follows (actuator electrical harness must be equipped with "Test" plug per Figure 2-6):

If gearmotor activates when installing MT558-1 tool then a spring switch has failed in closed position; immediately remove MT558-1 to prevent actuator damage.

- b. Disconnect MT558-1 tool, connect opposite end to actuator test plug, and verify gearmotor remains off.
- c. Disengage clutch and turn BATTERY switch off.
- d. MT558-1 pins 1 & 2 jumper tests wire 98 spring switch; pins 2 & 3 jumper tests wire 91 spring switch (see Figure 14-1D). Replace any malfunctioning switch per § 7.551 before further flight.

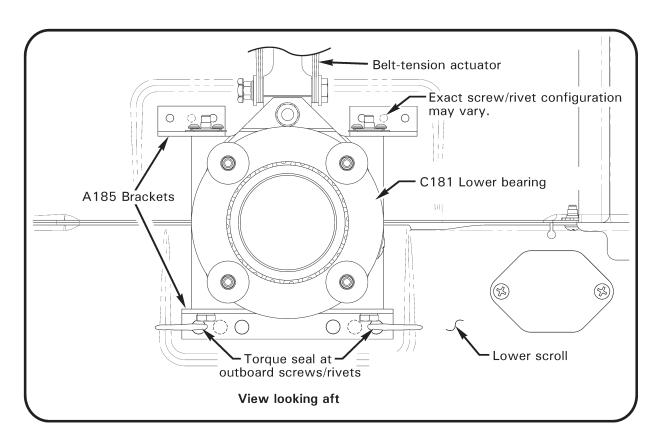
FIGURE 2-11 ACTUATOR LOWER BEARING A185 BRACKETS

Lower Bearing Brackets: Refer to Figure 2-11. Visually inspect A185 brackets and attaching screws/rivets for evidence of fretting or looseness. If evidence of looseness is found, contact RHC Technical Support for repair instructions. On lower A185 bracket, apply torque seal in a horizontal stripe across both outboard screws/rivets to lower scroll to facilitate future inspections.
